Subject: **Concrete Coring Results for the Roof of the
Existing Howard Theatre, Located at 7th and T
Streets, Northwest, Washington, D.C. (Our
Reference No. 03121108)**

Re: Howard Theater

JOB Howard Theatre

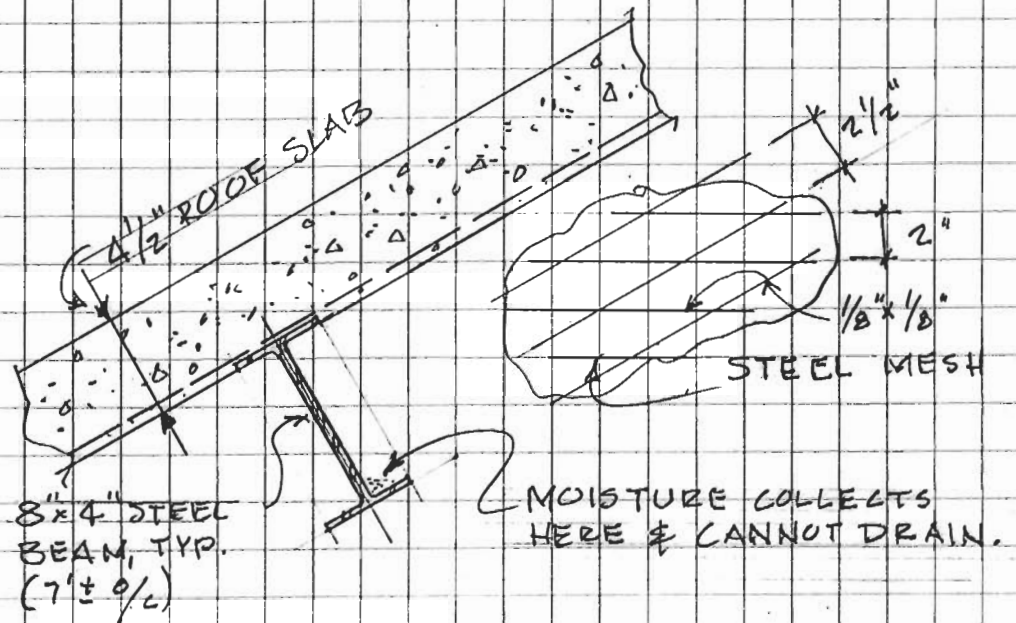
TYPICAL ROOF CONSTRUCTION
SCALE: 1 1/2" = 1'-0"

2. Accessibility restrictions prevented examination of most of the steel roof framing, however those members that support the roof slab and are over the balcony could be reached from the scaffolding erected. In general it was found that a major build-up of rust is occurring along the upper surface of the roof purlins at the intersection of the bottom flange and the beam web as shown in the enclosed sketch. Moisture collects at this location along the beam and forms a puddle, which does not drain.

Although complete deterioration along this part of the beam has not yet occurred, the roof leaks and continual presence of moisture in the building will eventually result in failure of at least some of these steel roof purlins. Analysis indicates that if they are intact, considering

no loss of metal, the existing purlins can safely support the roof load. Deterioration has resulted in some loss of section, which means that steel plates or angles will probably need to be added. During any renovation, all of the roof steel will have to be cleaned and examined.

Before the existing conditions become worse, we recommend a new watertight roof plus the installation of some venting of the interior space.
